Date of Inspection April 20, 2022

Re: Engineering report for the building at 712 16th Duplex April 2022

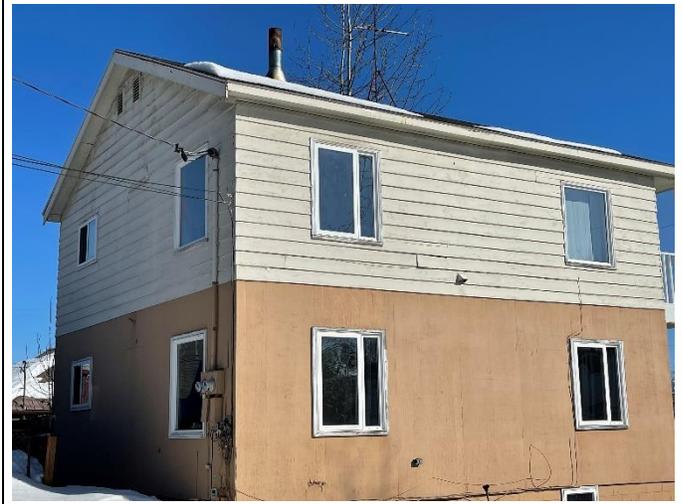
Some foam on the CMU foundation walls – not much. Add more for energy conservation.

- r. Cover the foundation wall on the exterior with foam and a weather protection barrier to reduce energy loss.

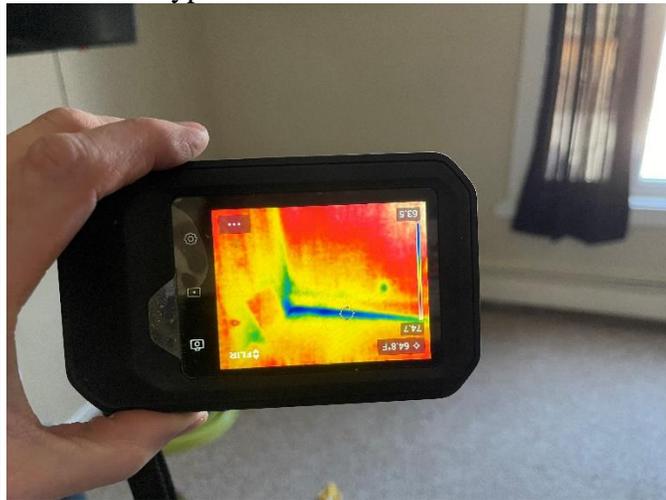
Avoid putting clothes and materials against an exterior wall of a closet especially if there is no heat pipes there to avoid mildew.

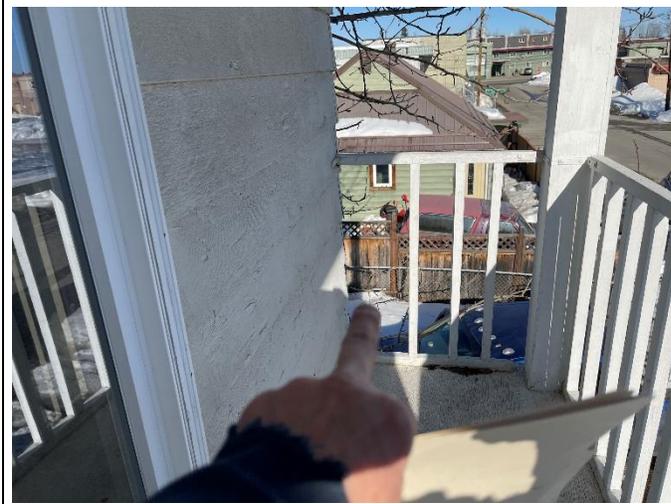
30. Replace the exterior door to the front porch upstairs. It is cracked and not designed to be an exterior door for this climate.
31. Replace the interior door to the bedroom upstairs. It is falling apart.

Replace this door with one designed for Alaska

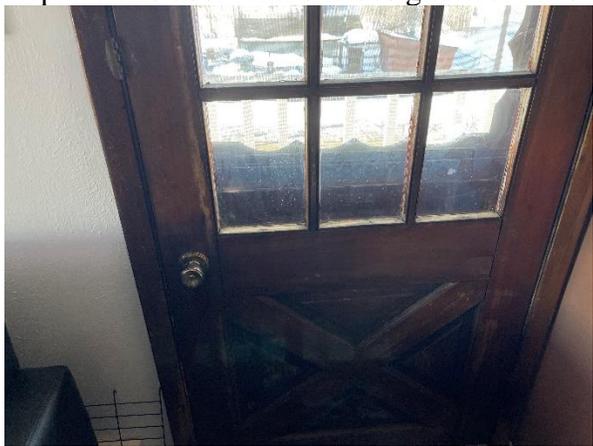
Door shown to the left is cracked.

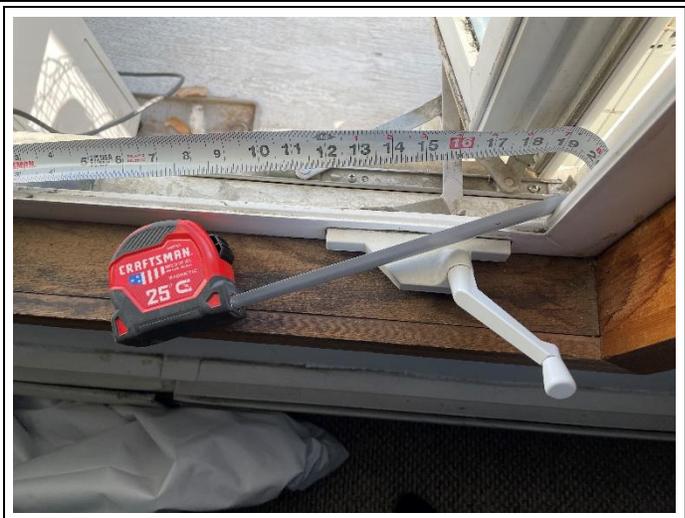
26. Install an egress window in each bedroom with the following minimums: Area - 5.7 s.f., width - 20", height - 24". Maximum sill height is 44" off the floor. The size of the opening that a person can fit through when the window is opened must meet all three minimums of area, width and height. I noted a newer upstairs bedroom window that only has a 16" clear width. It should be replaced.

Window clear width to be 20" or more

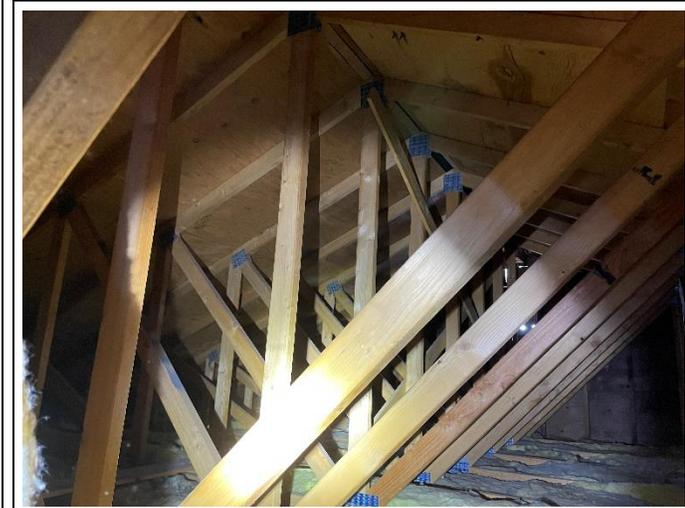
- d. There appeared to be about 10” of fiberglass batt in the attic where I measured. The existing old raftered flat roof may have another 5.5” more. You could put in another 4” to 5” but I would make the upgrades to the boiler first.

Attic insulation above the flat roof
