**VINCE MEURLOTT P.E.  
ENGINEERING AND INSPECTIONS**

Date of Initial Inspection: May 20, 2022

Job: 715 Farmers Loop May 2022

To: Daniel & Michelle Bettis

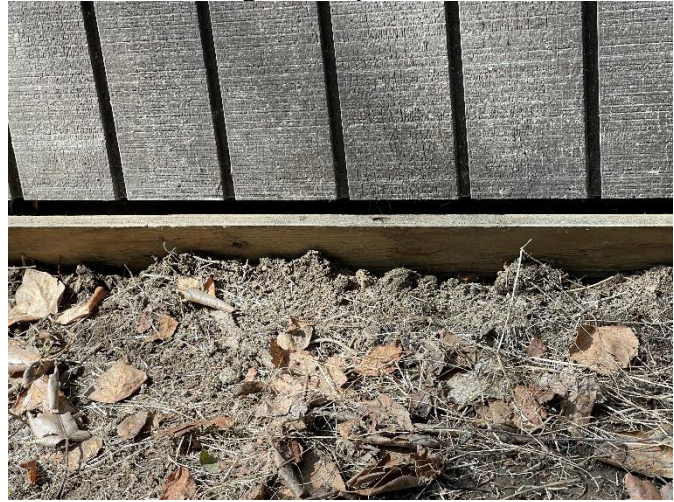
- k. The top and bottom of the foundation wall is pushed in on the east side. This is most likely due to hydrostatic load from water. There is fairly good drainage now achieved by swales and a drainage ditch on the east side.

East foundation wall is pushed in at the top.

- l. I concur with the analysis and opinion explained by Charlie Jeannet, North Star Engineering with regard to soils and the foundation movement in the report dated March 30, 2009. The east foundation wall could be reinforced more where it is pushed in and damaged but design of same is beyond the scope of this report. It seems that if you maintain drainage additional repairs may not be economically worthwhile.

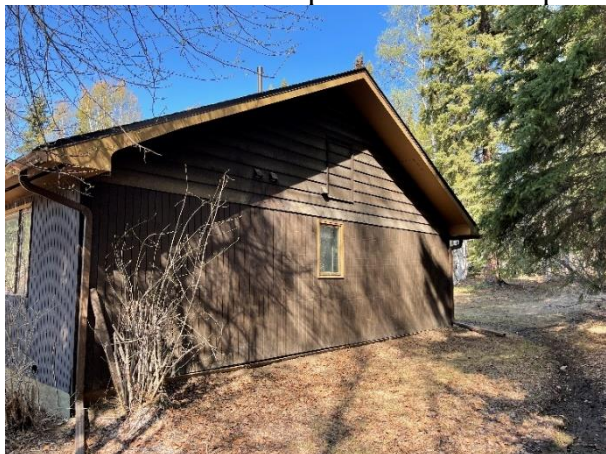
Foundation footing on east side is pushed inward and broken.

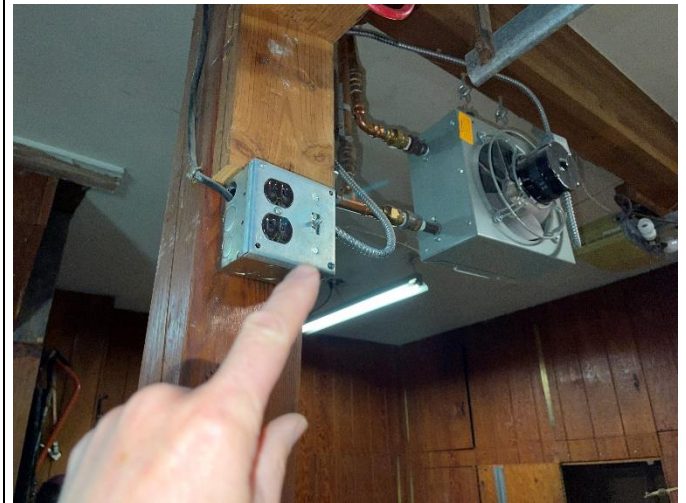
Electrical box in garage cabinet

12. Clean up wiring (if used) and cover box in garage cabinet.
13. Install covers on boxes, receptacles and switches where missing. General. Check all.
14. Replace broken receptacles such as: behind the woodstove, loft closet.

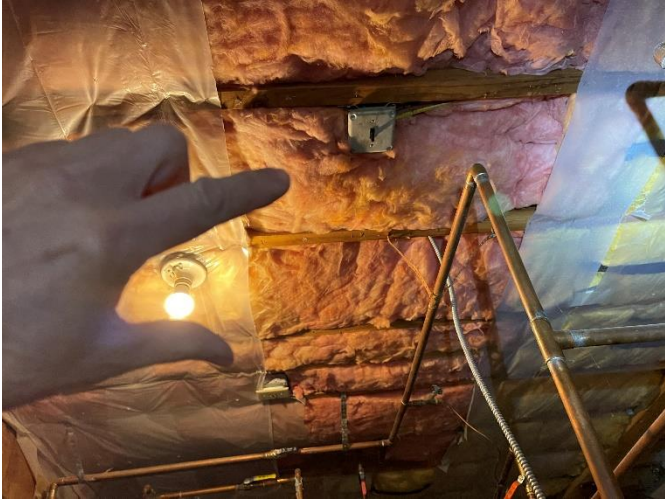
Label switches in the ceiling of the crawlspace.

31. Adjust all the plumbing drains in the crawlspace so there is a full 1/4" per foot slope.
32. Cure leaks at sump pump and container in the crawlspace.
33. Support the plastic piping in the crawlspace every 4' and metal piping every 10'.
34. Install support (typically staples) for all wires in the crawlspace every 4' minimum.
35. Label two each ceiling switches for function.

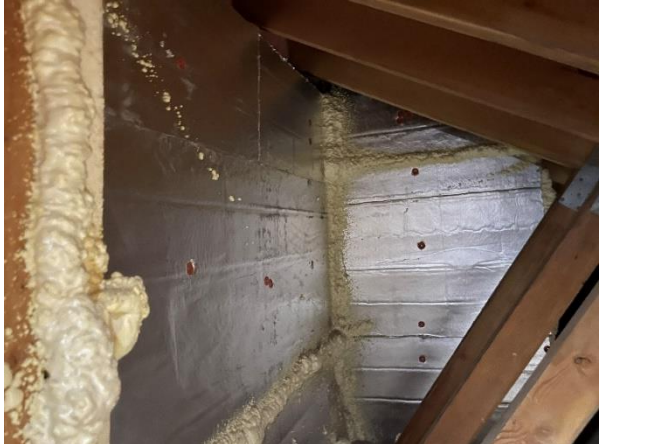
Rafter space over loft. Hot roof.
