**VINCE MEURLOTT P.E.  
ENGINEERING AND INSPECTIONS**

Date of Initial Inspection: August 22 & 24, and September 12, 2022

Job: 620 Gaffney Commercial Bldg August 2022

To: L&P Investments Group Alaska, LLC

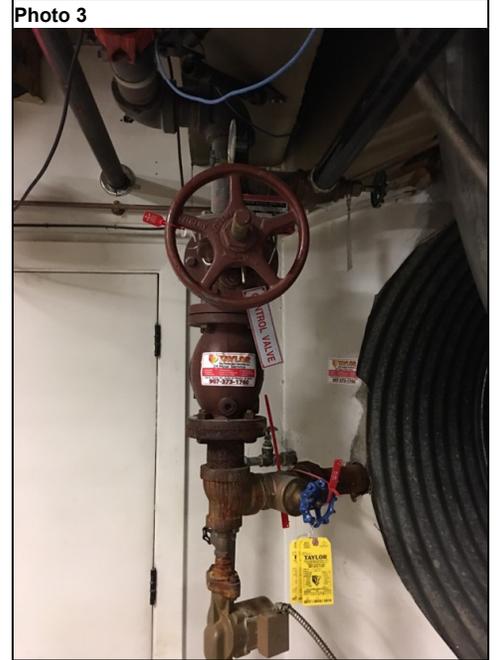
**Photo 3 Description**  
System left in service

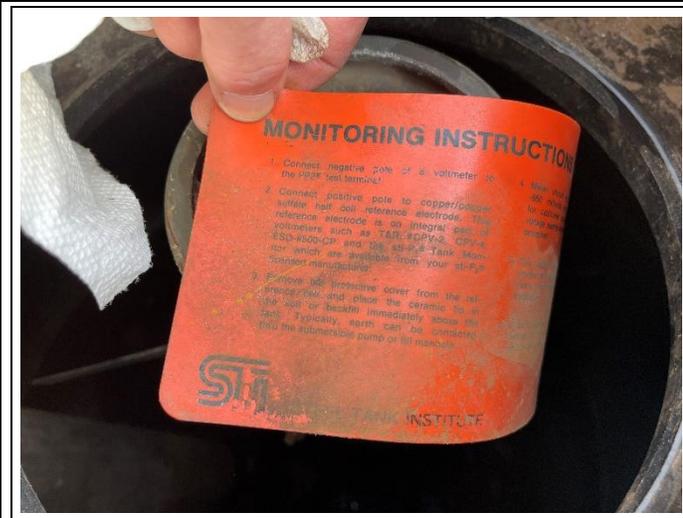
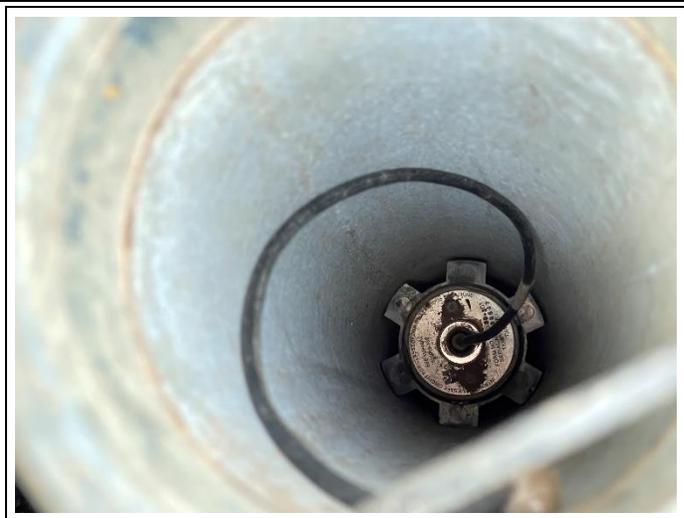
- k. There is a monitoring system in the “well” for the oil tank. I believe it may be for leaks from an old dry cleaning facility in the area. My brief search did not reveal that this particular property had any leaks. You may consider checking with DEC yourself and ordering a Phase I environmental study.

Monitoring system next to the oil tank access.

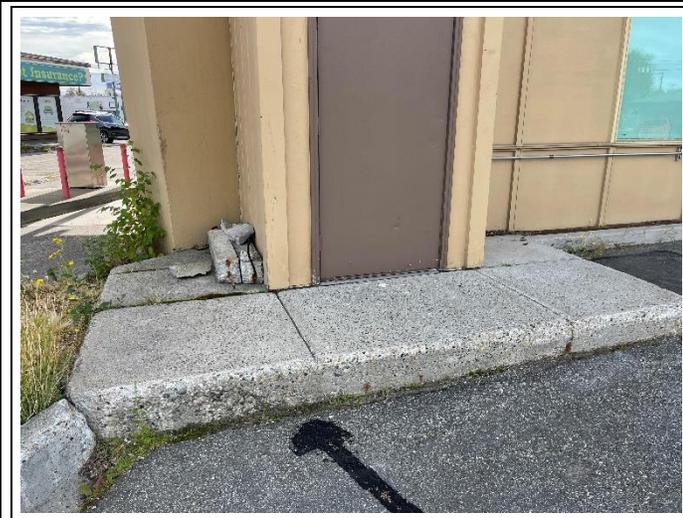
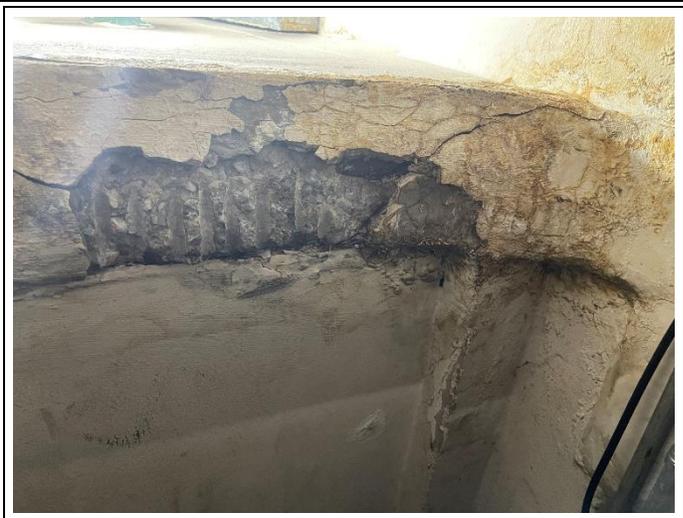
- a. There is a non-complying "stair" out of the basement. Risers are about 12" high. Damage to the concrete on ceiling of second" exit is assumed to be old.
- b. There is a sprinkler system for the basement. It appears to be properly installed and maintained. The last service by Taylor Fire Protection Services was in 2021 per the tags left on site. I assume that the basement sprinkler system was installed due to the lack of a proper second exit.
- c. There was less information on the original construction this structure in the Building Department Files than usual. The building appears to well designed and constructed.

Exterior door for “ second” exit out of basement. Damage to ceiling of “second” exit.

- j. Repair damage to concrete at head of the non-compliant second exit. We assume this was from an old leak before the newer roof covering was installed.

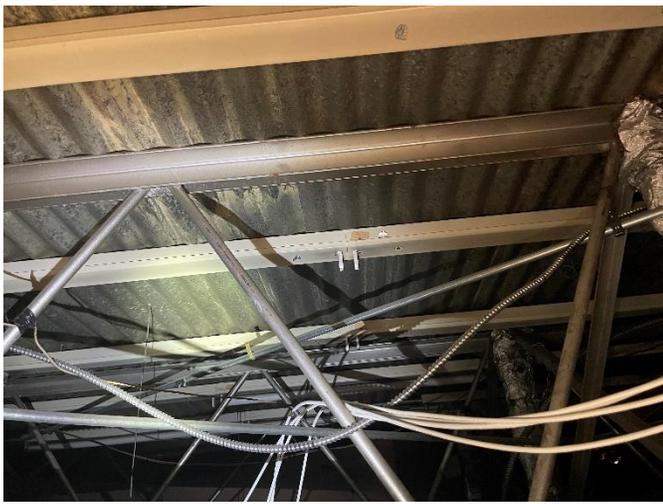
Struts from the roof structure in the space above the suspended ceiling are insulated. I assume this is to reduce condensation.
