**VINCE MEURLOTT P.E.
ENGINEERING AND INSPECTIONS**

Date of Initial Inspection: September 21 & 25, 2022

Job: 750 Farmers Loop. Prelisting September 21, 2022

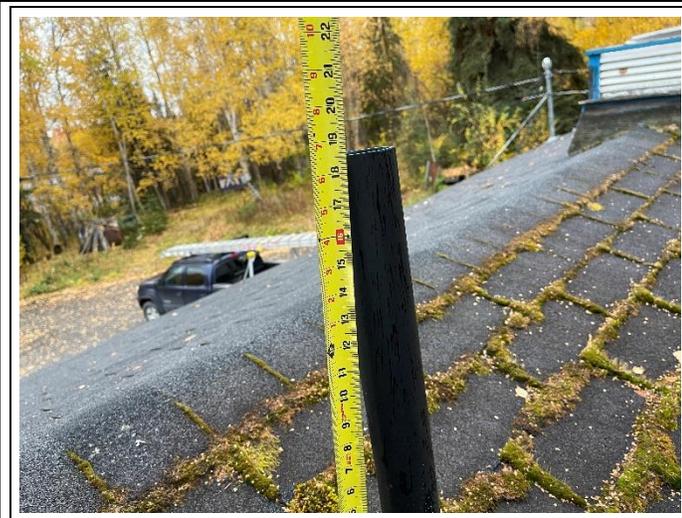
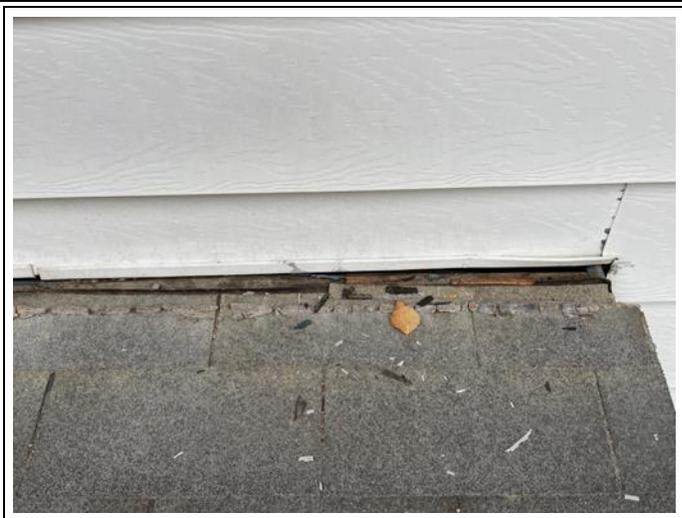
Cut plumbing vents so they only extend 10" above the roof. Add flashing where missing.

- h. The roof framing consists of older premanufactured trusses. They are usually sufficient for our snow load.
- i. Cut the plumbing vents at the angle of the roof so they only extend 10" above the roof to reduce freezing during very cold temperatures.

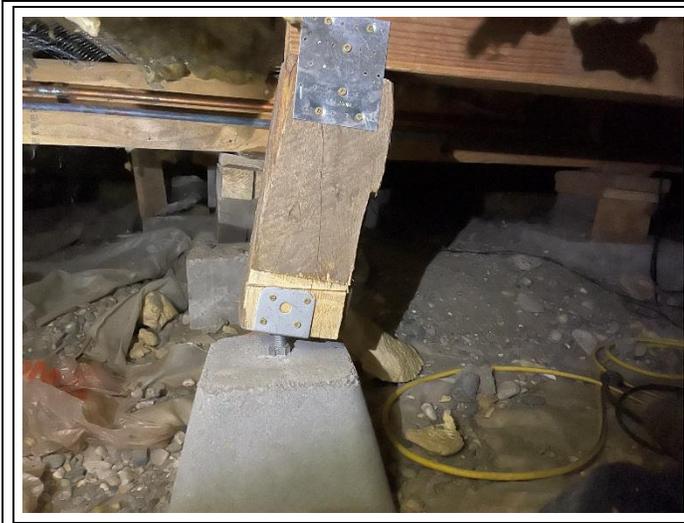
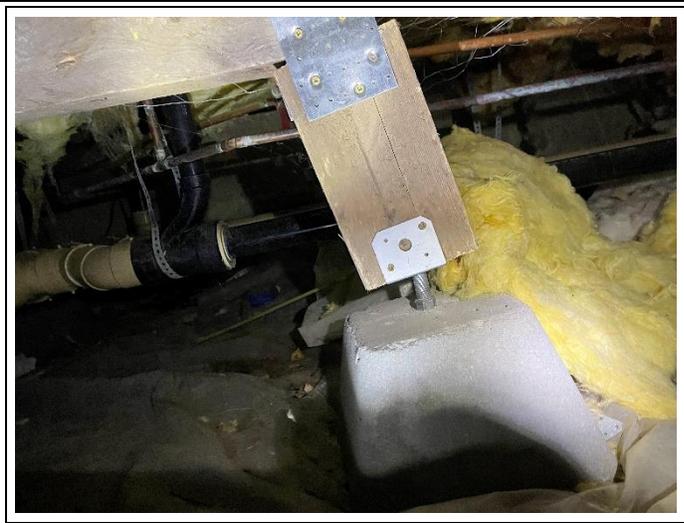
Plumb the 4x4 interior posts used to augment interior joist support

44. Cure leak at the main drain where it enters the soil on the south side near the front door.
45. Plumb the 4x4 interior posts used to augment interior joist support where not vertical.
46. The north footing has been raised and supported by large bolts and steel brackets. Install concrete footings or cement pads between the gravel and the bottom of the footings every 4' to provide proper support to the footing at gaps between the gravel and footing.
47. Install support (typically staples) for all wires in the crawlspace every 4' minimum.

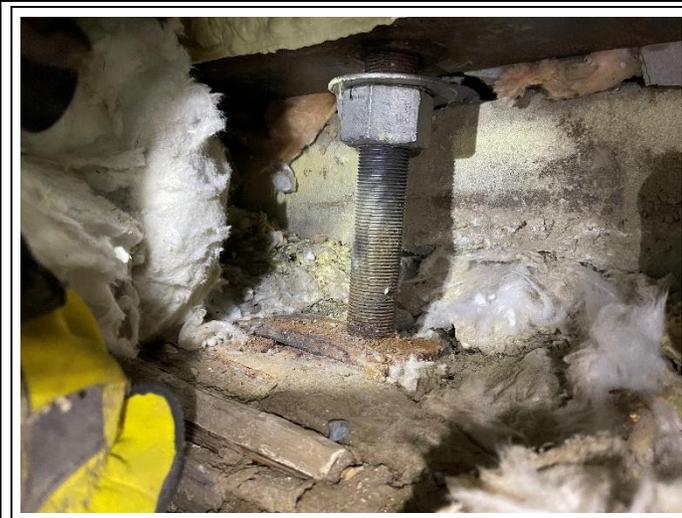
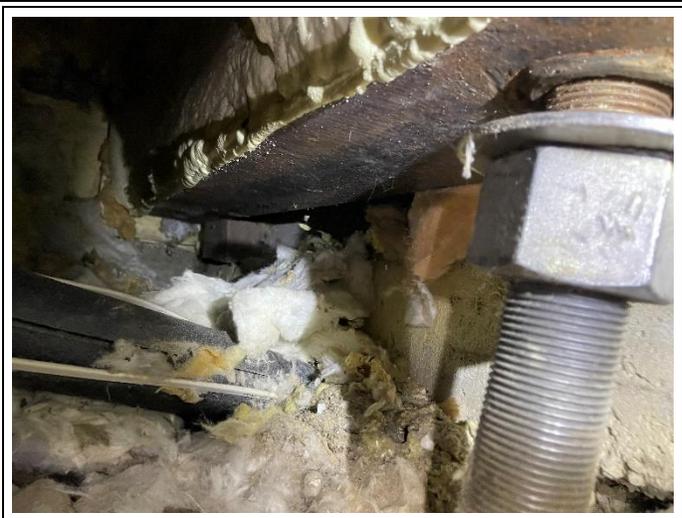
The north footing has been raised and supported by large bolts and steel brackets shown above. Fan and duct and heaters in crawlspace shown below.

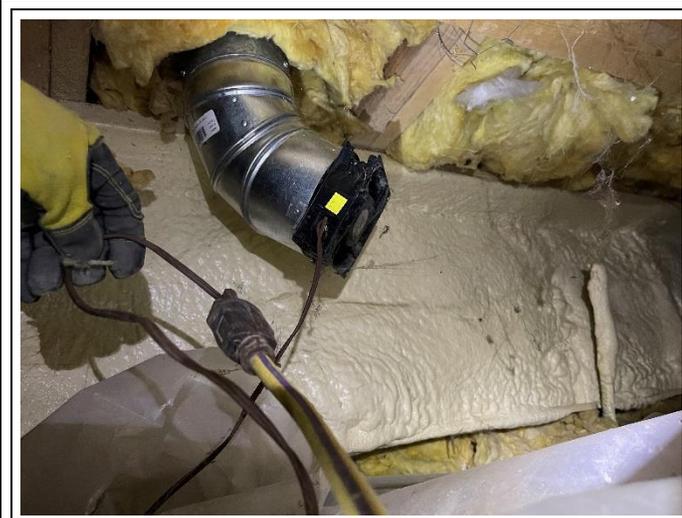
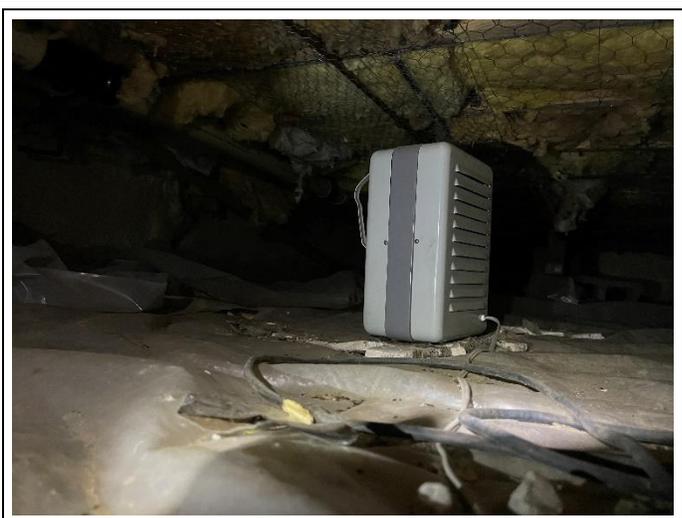
- f. There are some electric heaters in the crawlspace to keep pipes warm.
- g. There is an electric fan in the crawlspace to circulate the warm air but it may not be functional now.

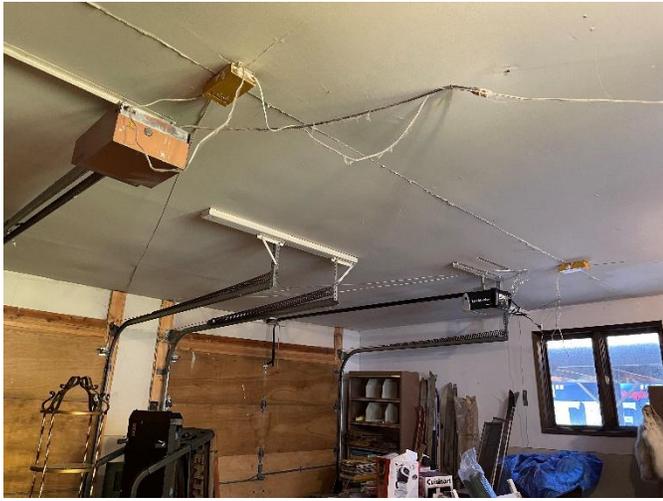
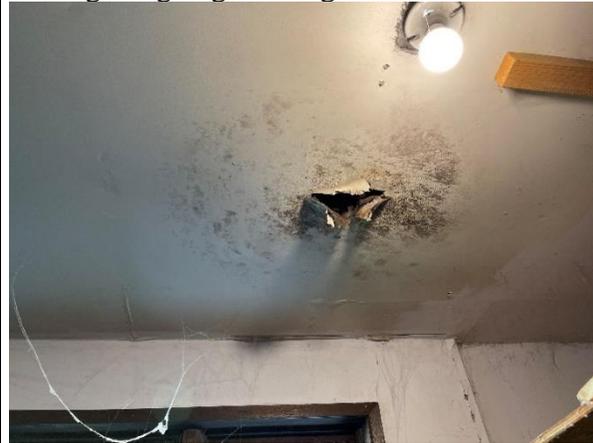
Damage to garage ceiling

41. Ensure there are two self closing hinges or other self closing mechanism on the door(s) from the living space into the garage. Adjust the door and hinges or other closing device so it closes and latches after each use.
42. Secure the step near the door into the house.
43. Repair gypsum wall board on the ceiling surfaces of garage.

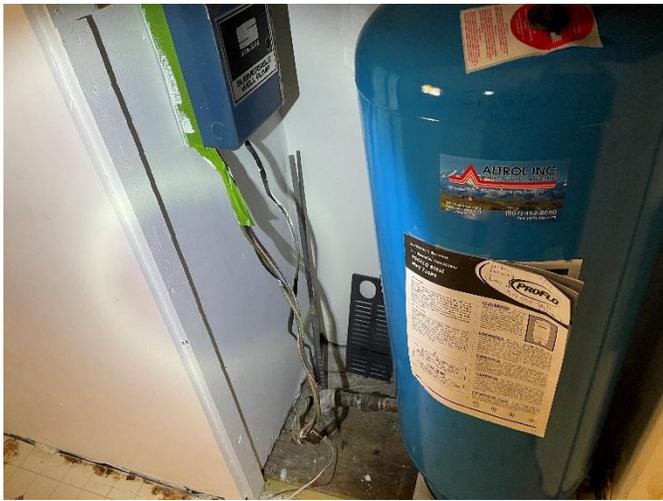
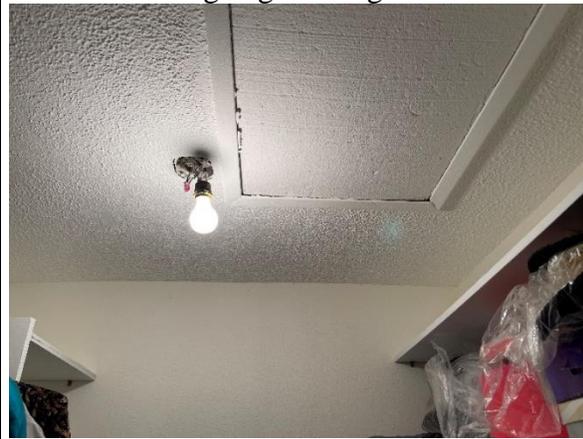
Attic access in garage ceiling

- l. Seal the ceiling attic access in the garage. Just use the one at the gable end.
- m. Sauna heater works I tested it.
- n. Consider application to FNSB for the fireplace/woodstove change out program.
