Dates of Initial Inspection: November 12 & 13, 2022  
Job: 3702 Cameron Commercial Restaurant November 2022

To: Doyon Foundation  
C/O: Selling Licensee: Marjorie Merry, Pruhs Real Estate Group  
Listing Licensee: Kelly Paschall, RE/MAX  
Seller: Estate of William Nault

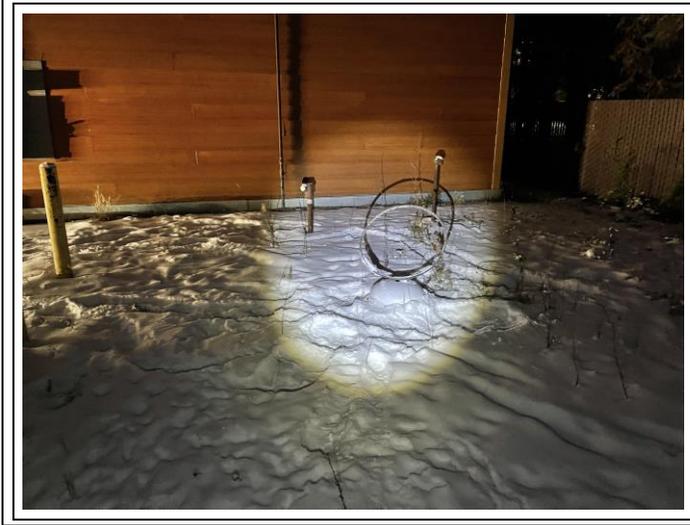
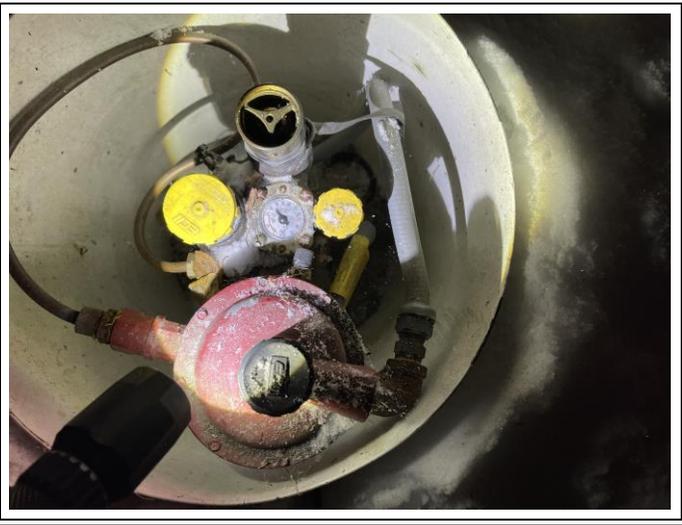
Electrical service equipment now secured. Oil tank and propane tank adjacent to service

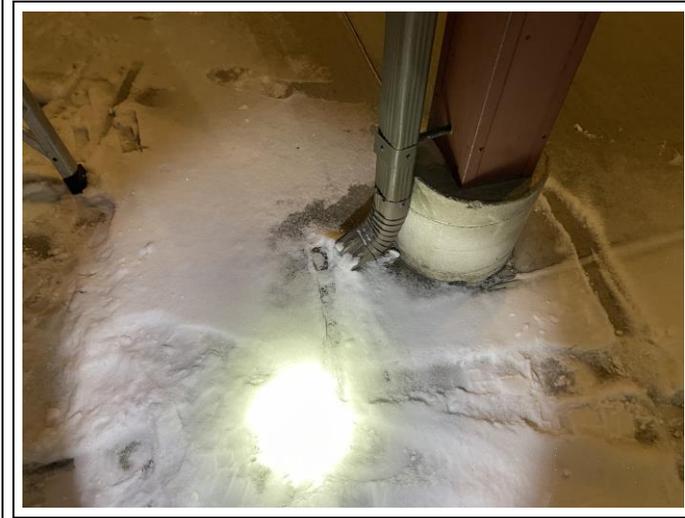
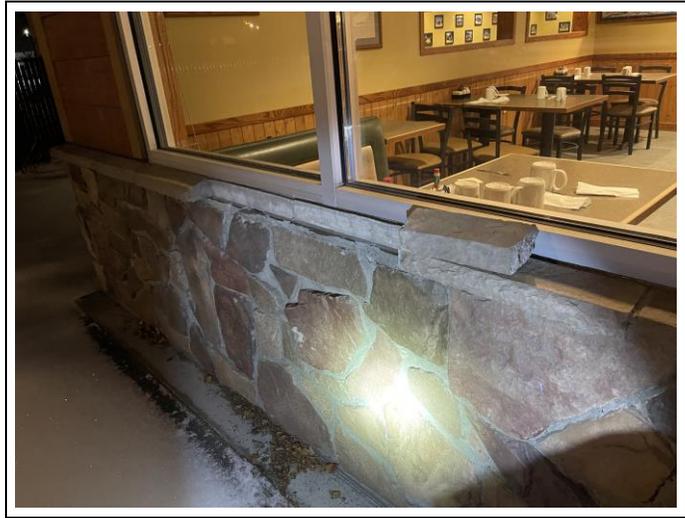
Sono tube form for column per plan. Some stone veneer caps are broken off.

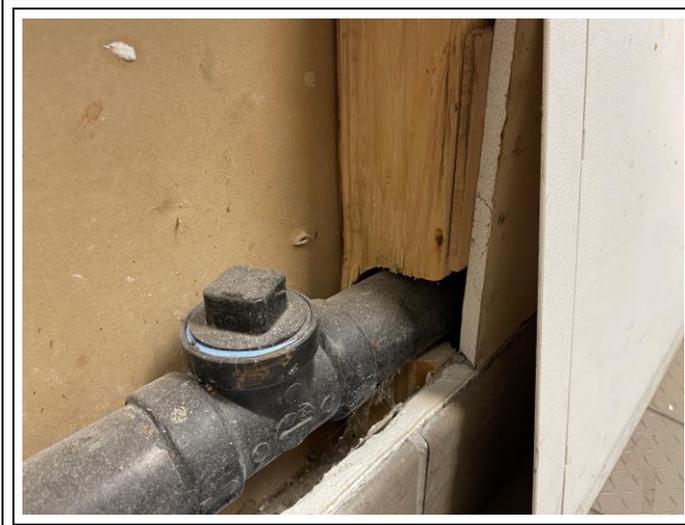
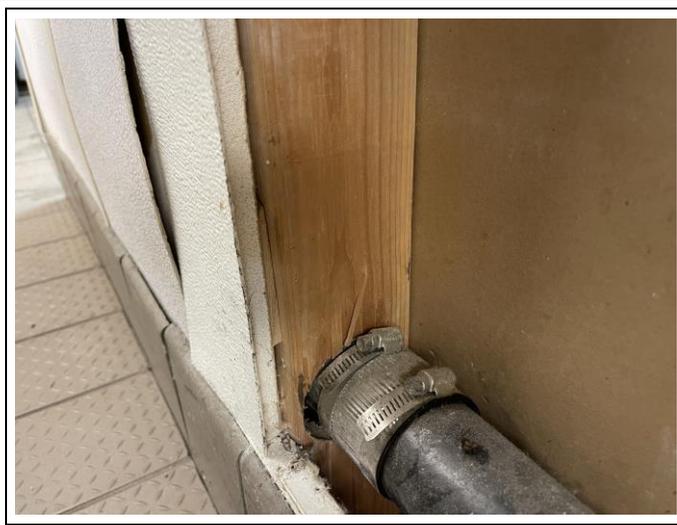
Mildew shown above left. No nail plates installed to protect drain lines shown below.

1. Install seismic bracing on the suspended ceiling grid up to the structure above.
2. Remove visible mildew noted on bottom of wall near electrical panels where materials were stacked against the wall.

8. Bring all toilets in the men's and women's restrooms to working order.
9. Install nail plates to protect the pipes less than 1.25" from the face of stud or plate.  
Gypsum board is already installed. I noted plates were missing on a couple of locations

where gypsum board was removed to repair plumbing pipes. Use caution when screwing additional items on existing walls where plumbing may be located.

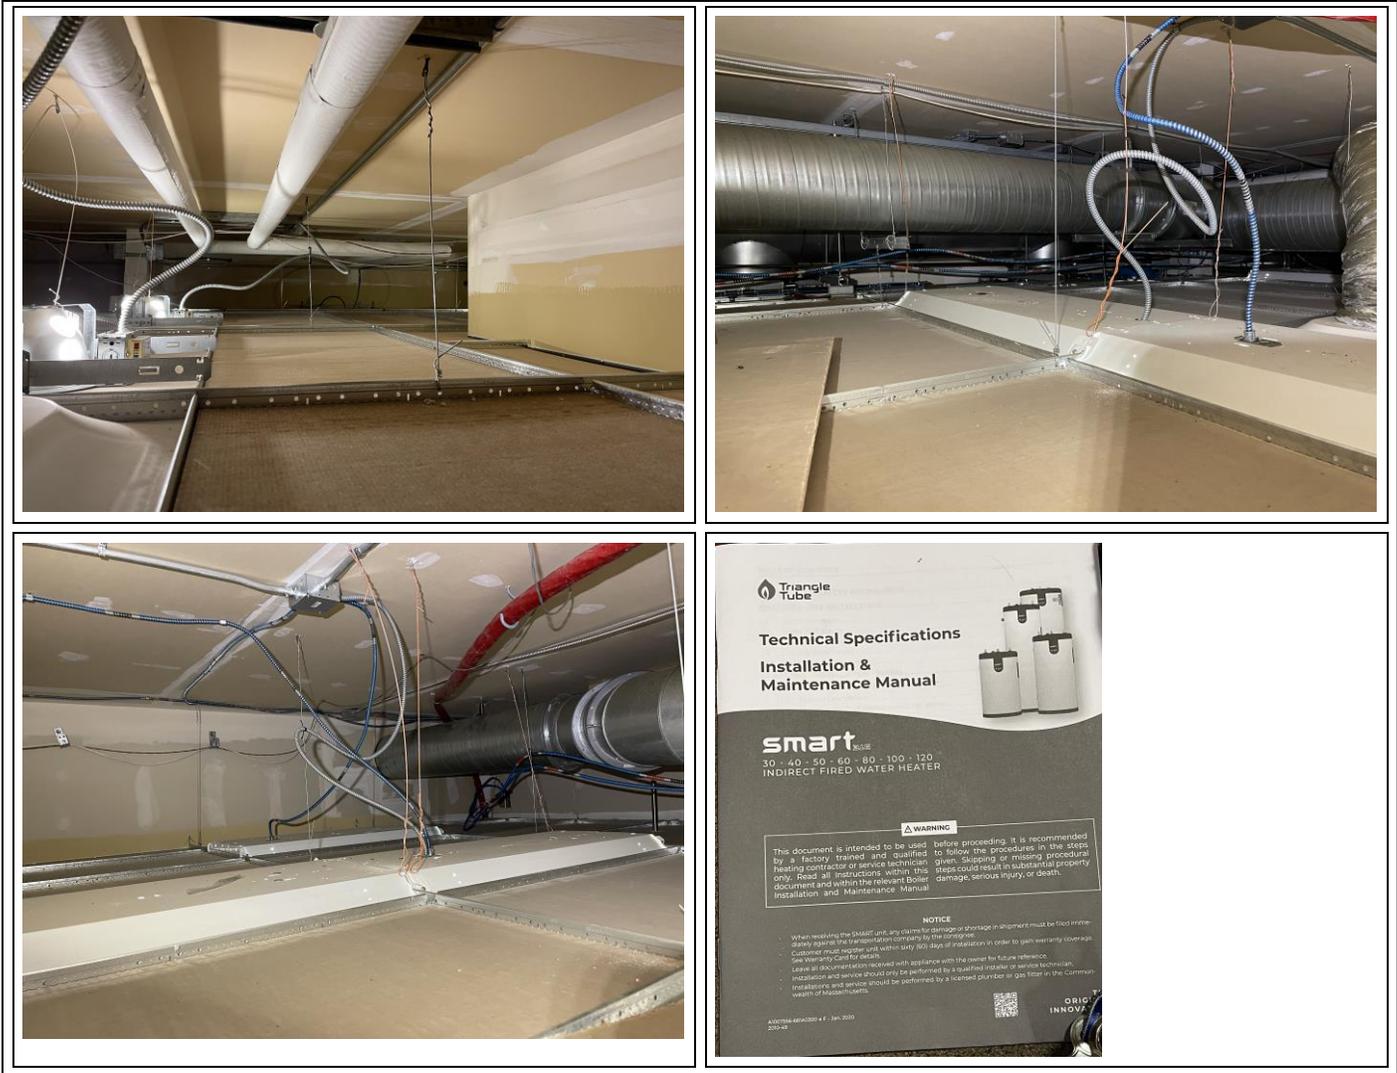
No seismic bracing for ceiling grid. Instructions for new hot water maker left on site.

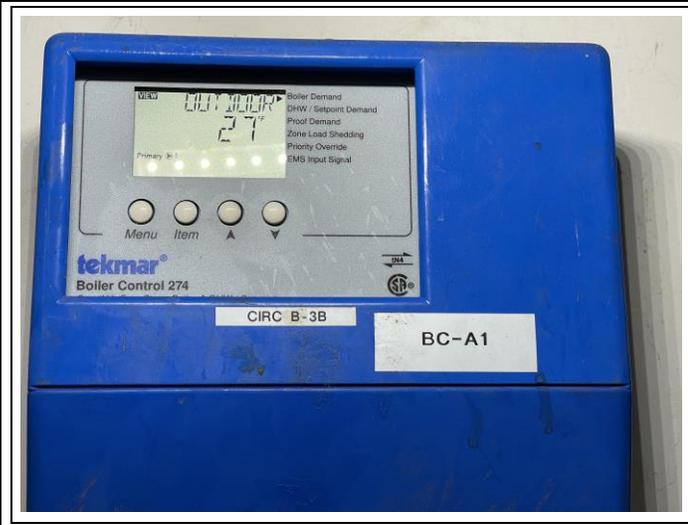
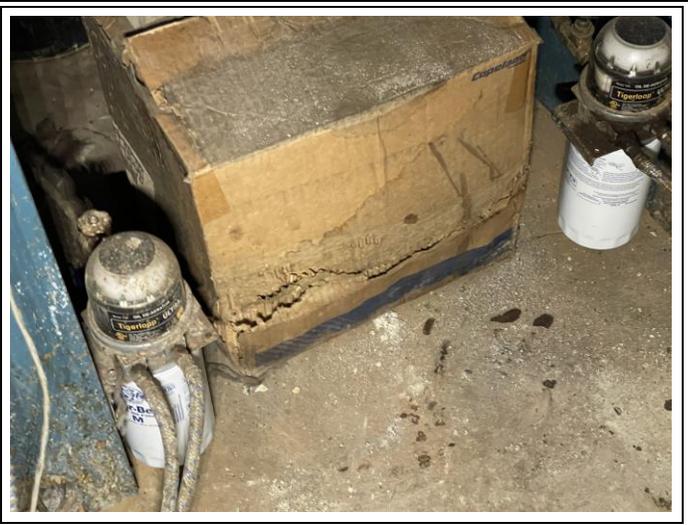
- a. Have a mechanical contractor make corrections to controls for the modulating aquastat and or the boiler temperature gauges. The outdoor temperature was + 28 F and the boiler temperature gauges showed temperatures of 190 and 210 F which I believe is too high such that the modulating aquastat is not working properly to save energy.

- b. IR photos show a good uniform heat distribution of radiant piping in the slab.
- c. The oil lines to the boilers have a "Tiger Loop Combi" (Combination deaerator with filter which eliminates air in the line and allows a clear visual observation of the oil and filter.

Tekmar Outdoor reset shown above left. Tiger loop shown above right.

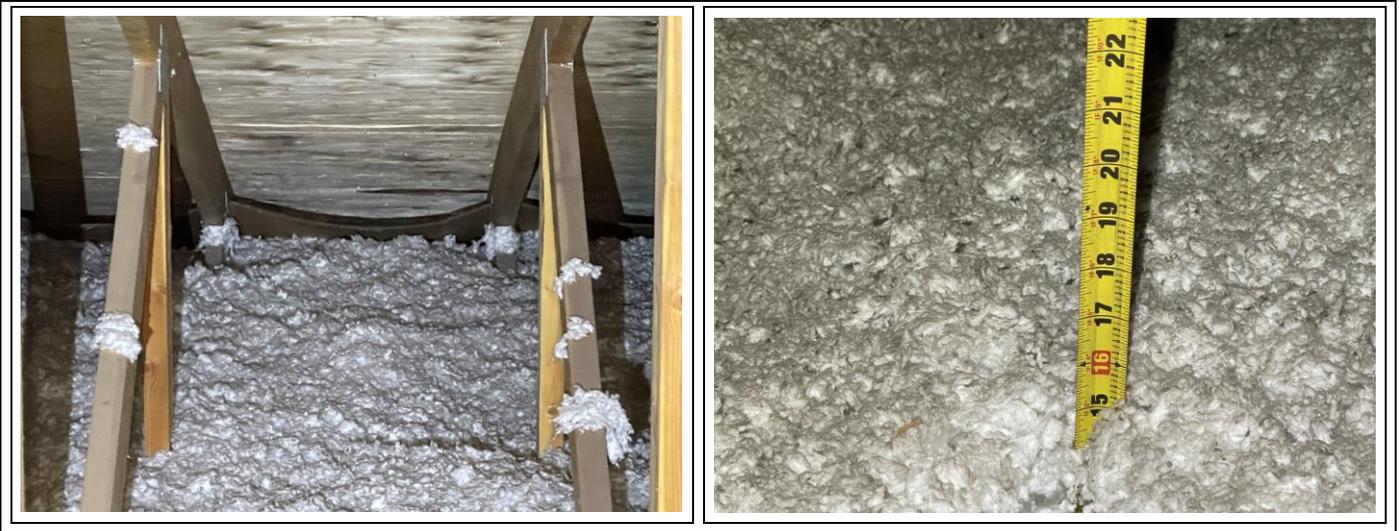
- e. Attic ventilation appears to be acceptable with baffles to maintain the eave ventilation at the soffits for a "cold" roof as desired in Fairbanks.

- f. There appeared to be about 16" of blown in fiberglass in the attic where I measured. Each inch of insulation is worth about an (R-3). Energy consultants in Fairbanks recommend a total R-value of 60 for energy efficiency. I recommend adding another 5" of insulation.

Cardboard baffles installed to maintain eave ventilation. Attic insulation is adequate but could be improved to save energy as fuel prices have risen. Trusses bracing acceptable.
