Date of Inspection April 20, 2022

Re: Engineering report for the building at 712 16th Duplex April 2022

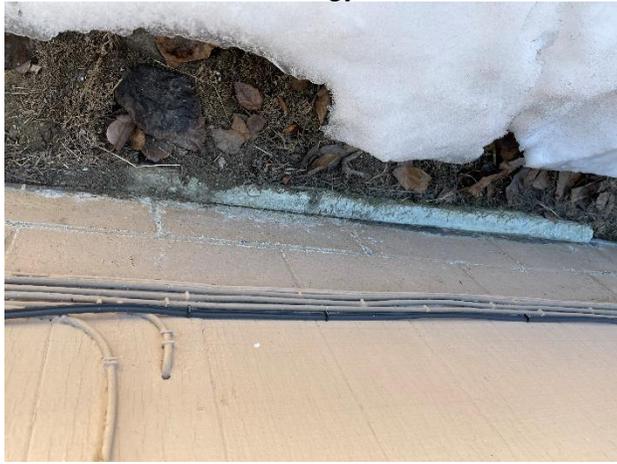
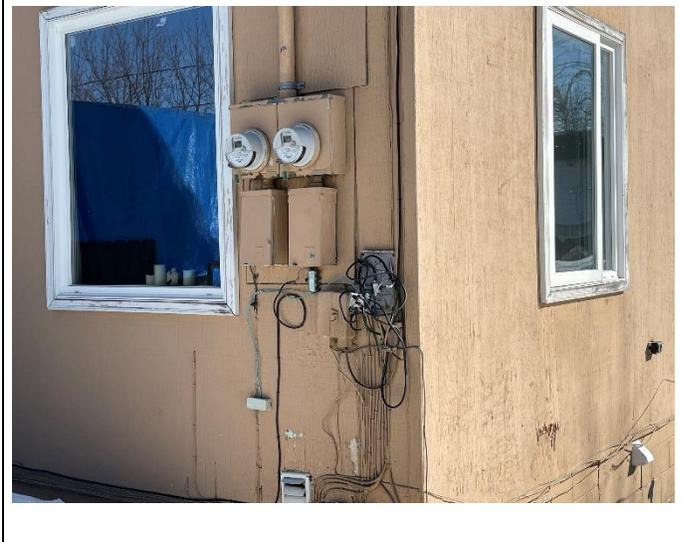
Some foam on the CMU foundation walls – not much. Add more for energy conservation.

- r. Cover the foundation wall on the exterior with foam and a weather protection barrier to reduce energy loss.

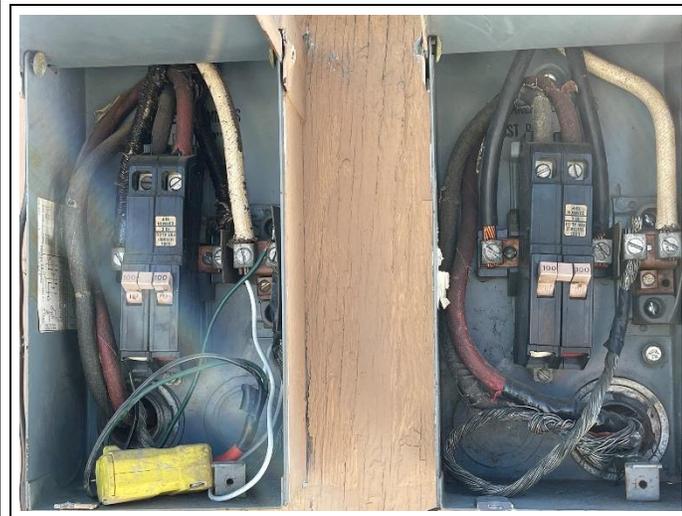
Remove small plug and wire in the left side exterior service box.

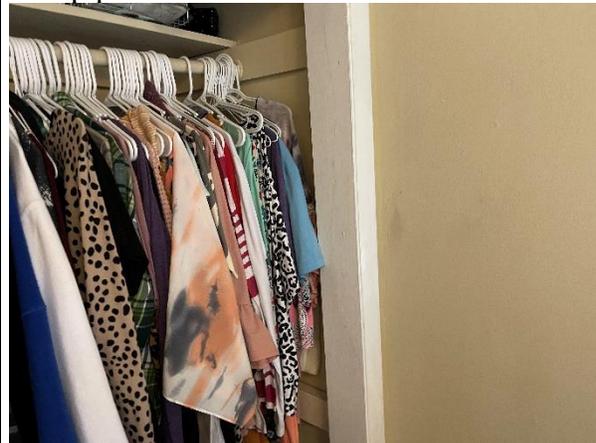
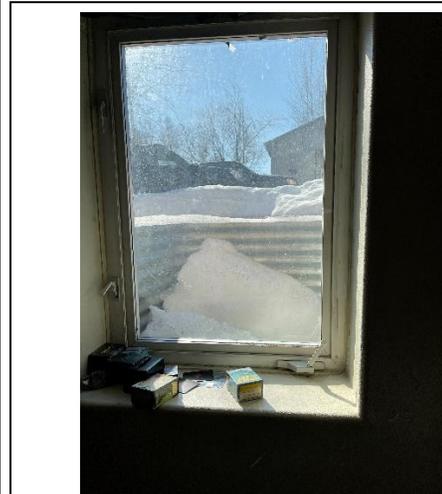
Some newer windows are nice.

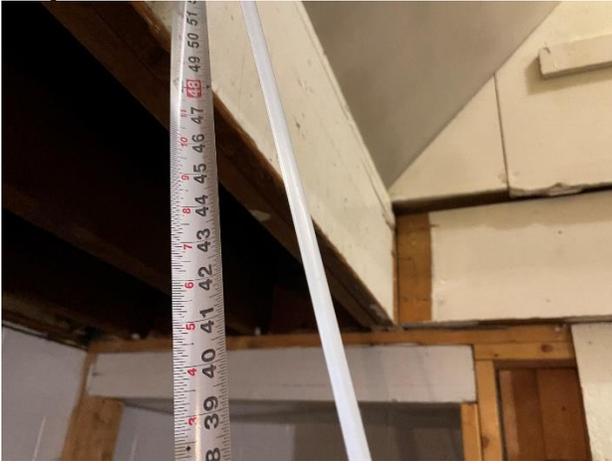
Very low headroom.

It would be best to provide a proper walking stair.

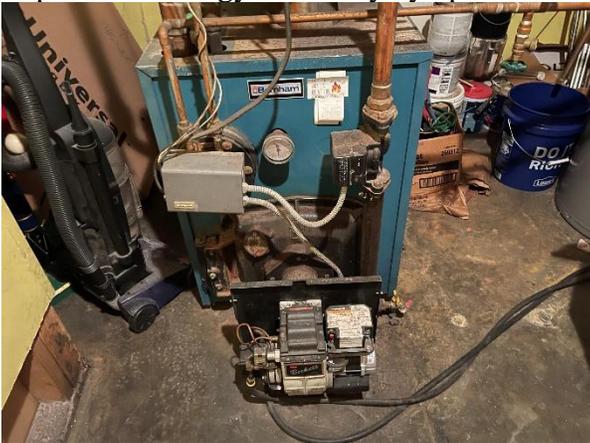
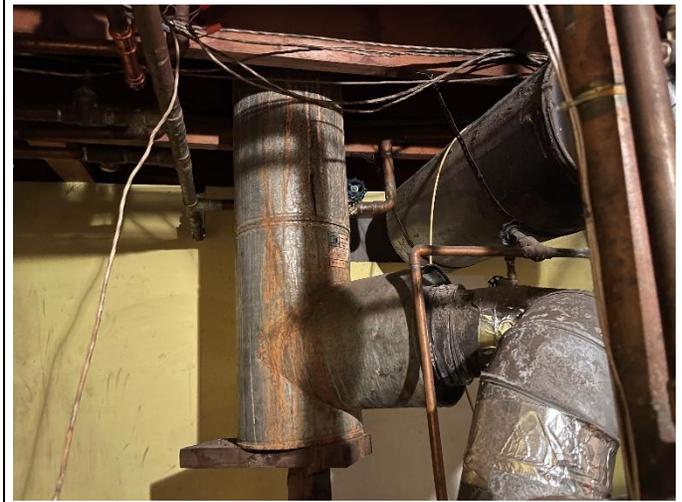
Fan blowing heat out of the boiler room.

- p. Share the excess heat from the boiler room with the adjacent living space in the winter.
- q. I noted the oil tank riser is pushed over. We do not evaluate the tanks but it may be prudent to replace the tank as excess force on the riser can create a weak spot subject to leaking which might allow water into the tank.

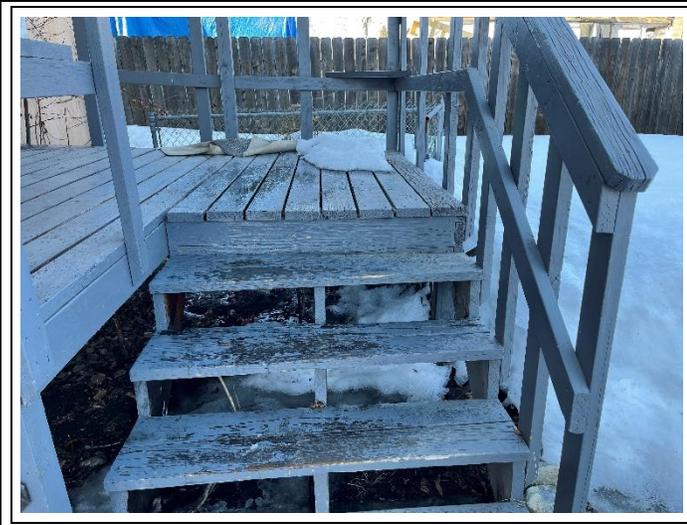
Fasten the deck ledger to the house

6. Fasten the deck ledger to the house with two each 1/4" diameter x 4.5" Simpson SDS Structural screws every 16".

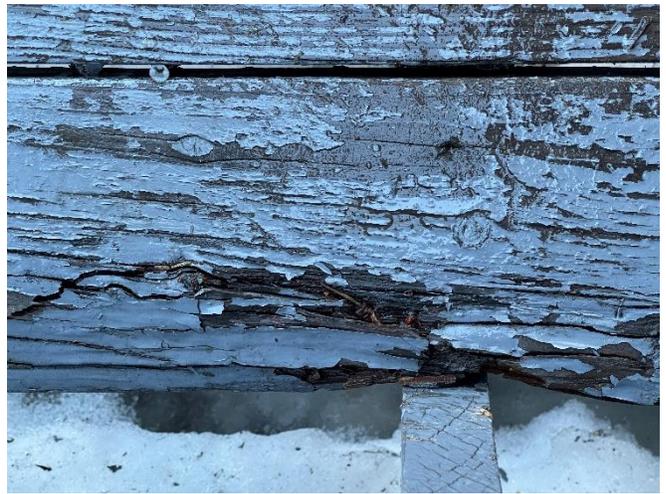
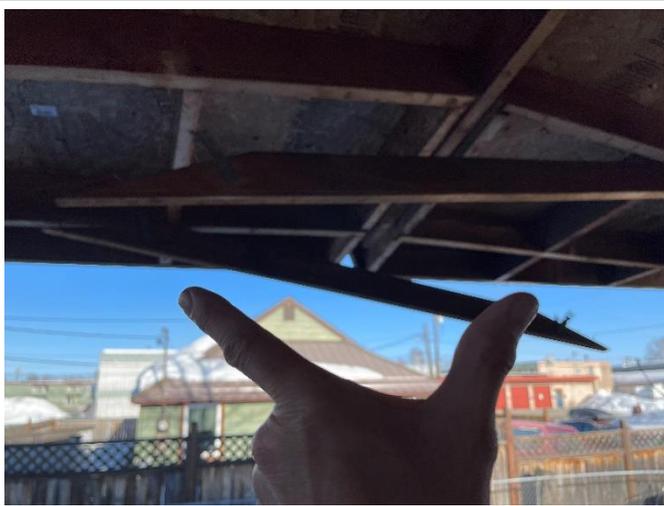
Replace all decayed lumber for the exterior porch with AWW material

Replace decking soon

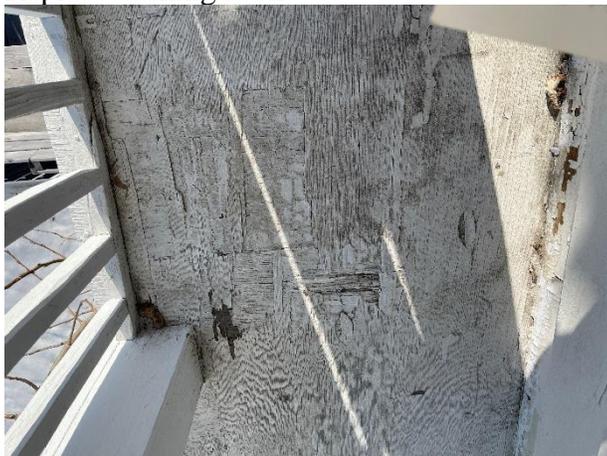
Replace this door with one designed for Alaska

30. Replace the exterior door to the front porch upstairs. It is cracked and not designed to be an exterior door for this climate.
31. Replace the interior door to the bedroom upstairs. It is falling apart.

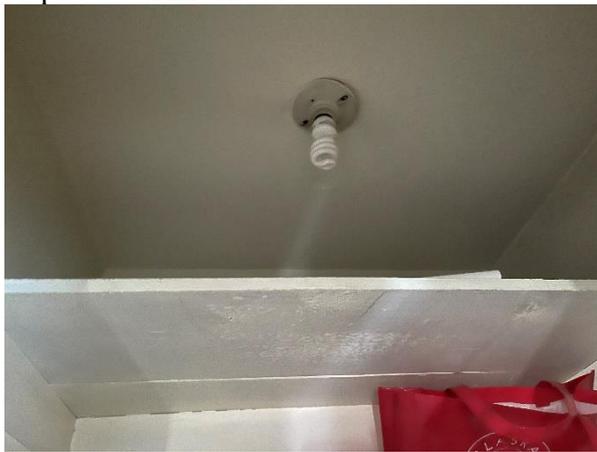
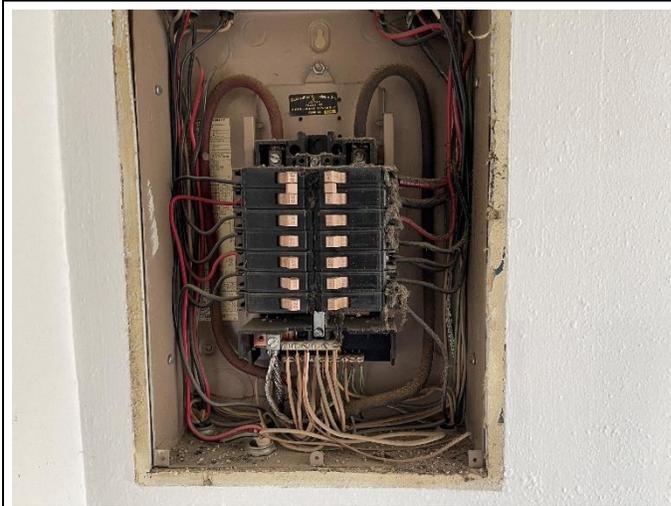
Replace w LED fixture

- h. Remove incandescent light fixtures within 18" of a plumb line above closet shelves. Replace them with LED fixtures or cap the box. Main level.
- i. Seal around the pipes with expanding foam or similar to stop any leaking around the pipes from the soil outside. Insulate the water lines to minimize condensation.

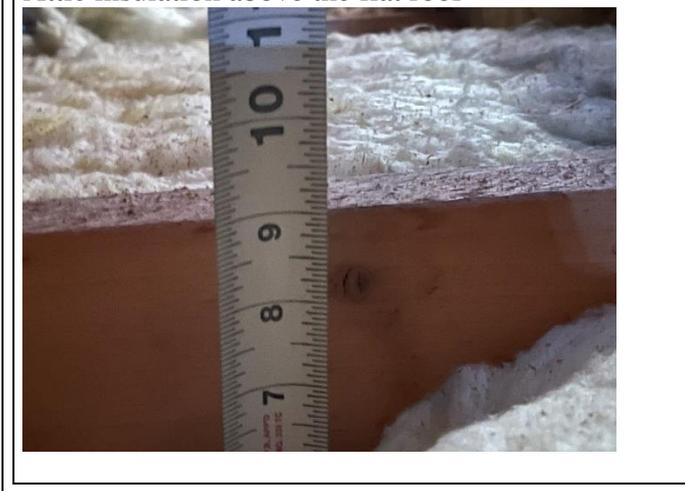
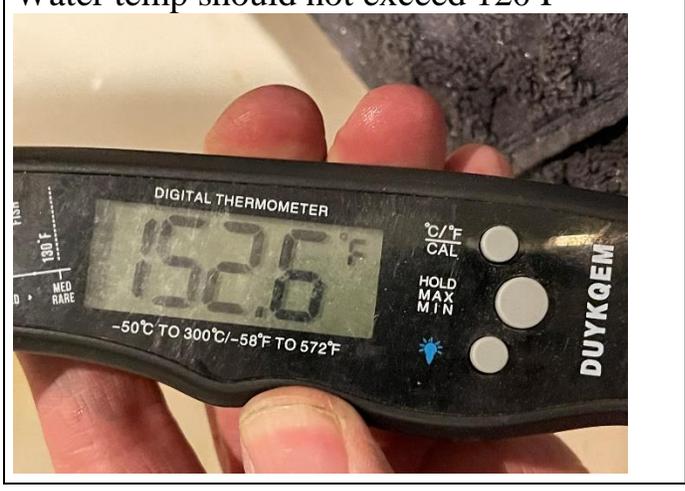
Water temp should not exceed 120 F
