**VINCE MEURLOTT P.E.
ENGINEERING AND INSPECTIONS**

Date of Initial Inspection: September 21 & 25, 2022

Job: 750 Farmers Loop. Prelisting September 21, 2022

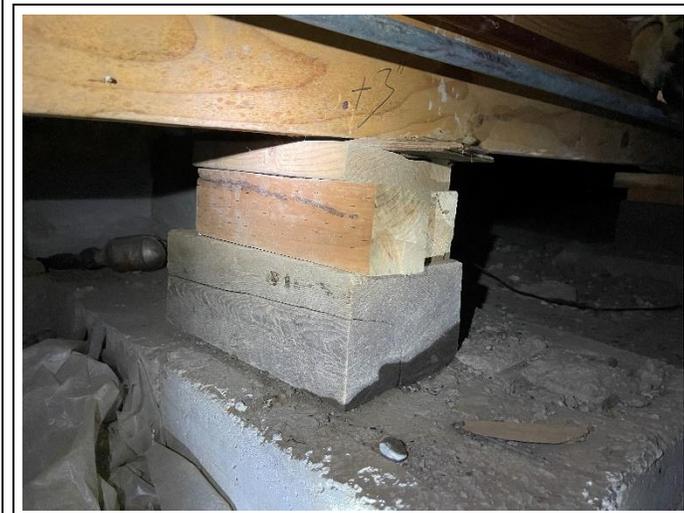
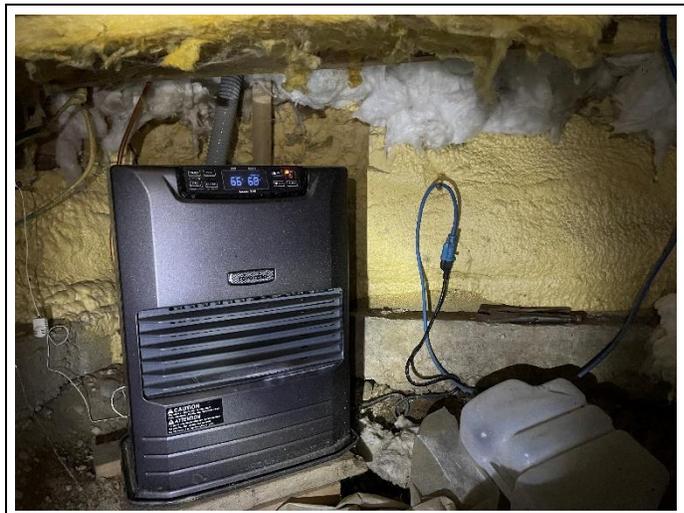
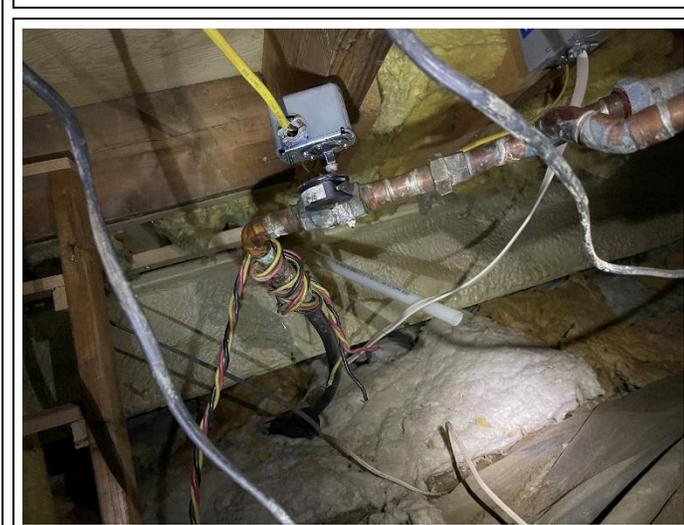
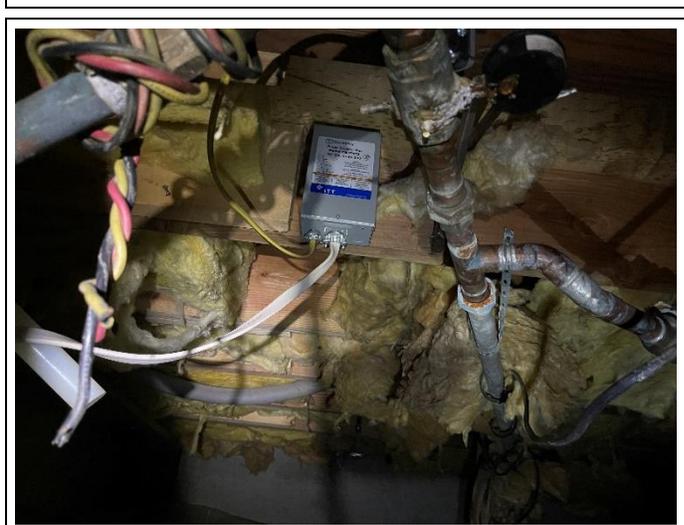
Plumb the 4x4 interior posts used to augment interior joist support

44. Cure leak at the main drain where it enters the soil on the south side near the front door.
45. Plumb the 4x4 interior posts used to augment interior joist support where not vertical.
46. The north footing has been raised and supported by large bolts and steel brackets. Install concrete footings or cement pads between the gravel and the bottom of the footings every 4' to provide proper support to the footing at gaps between the gravel and footing.
47. Install support (typically staples) for all wires in the crawlspace every 4' minimum.
