**VINCE MEURLOTT P.E.  
ENGINEERING AND INSPECTIONS**

Date of Initial Inspection: August 22 & 24, and September 12, 2022

Job: 620 Gaffney Commercial Bldg August 2022

To: L&P Investments Group Alaska, LLC

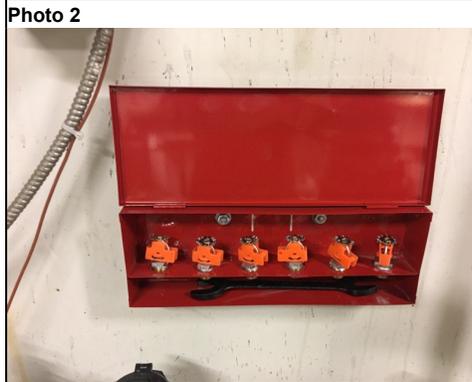
**Photo 2 Description**  
Head cabinet

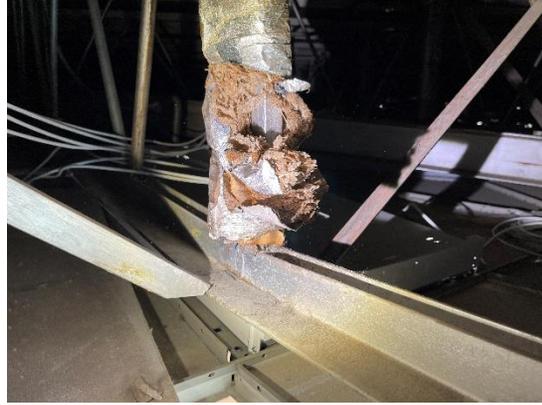
Struts from the roof structure in the space above the suspended ceiling are insulated. I assume this is to reduce condensation.
